1234, Murfreesboro, TN

Address:	2174 Main Street Murfreesboro, TN
Store Number:	1234
Date Visited:	1/1/2026

413 Solution Property Risk Survey

Survey Completed Date	January 1, 2026
Surveyor	John Doe

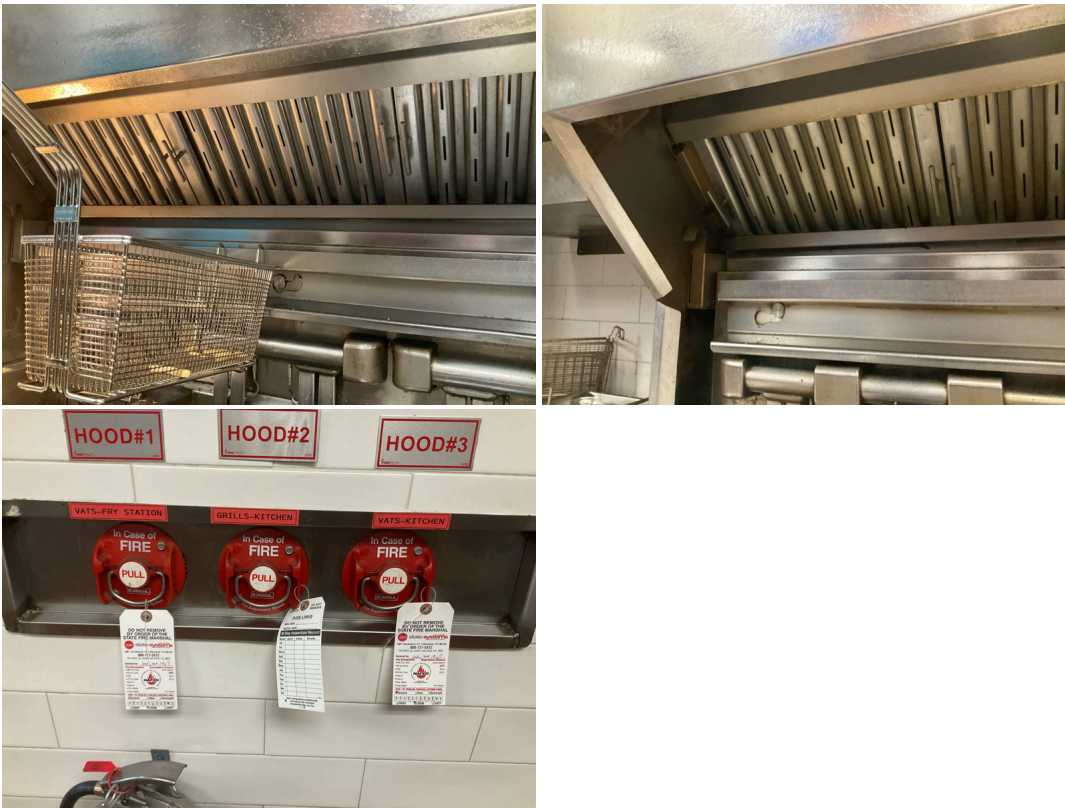
Hood Suppression System photos

Is there a hood suppression system? | Yes

Is it clean? | Yes

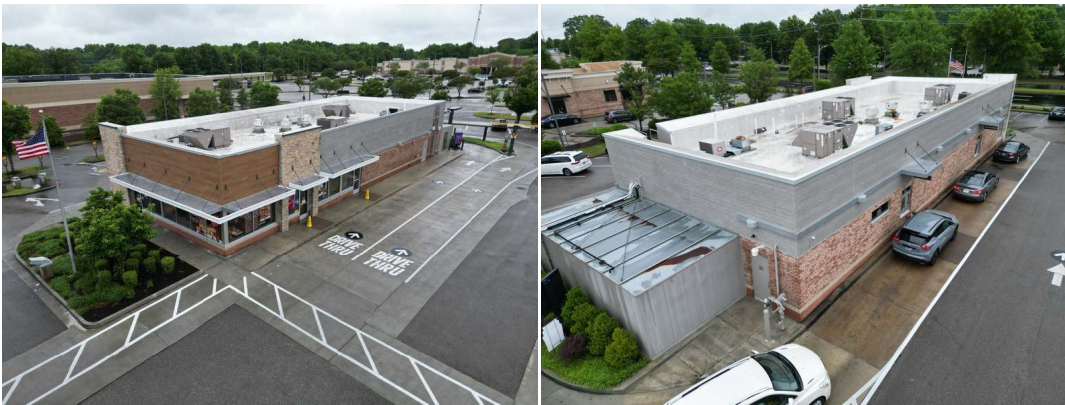
Building Condition Photos

Contents Damage Modifier (Factors in Surge/Flood modeling only)	Moderate = 2: A typical percentage or the contents are water-resistant or protected
Number of Risks	1
Construction Code Type	AIR ▶ 119 - Joisted masonry
Other Construction Codes	RMS ▶ RMS 2C-Structural Masonry
Occupancy Code & Type	AIR ▶ 331 - Restaurants
Year Built	1972
Building Condition	2 = Good

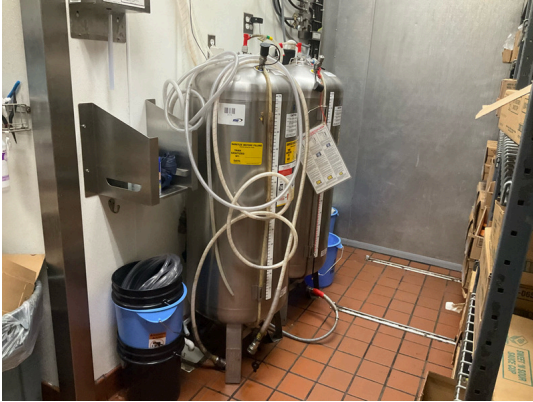
Equipment Photos

Equipment | Unbraced = 3

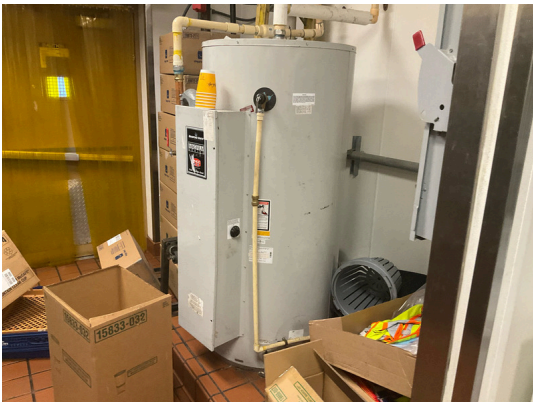
Water Heater Photos

Water Heater | Unbraced = 2

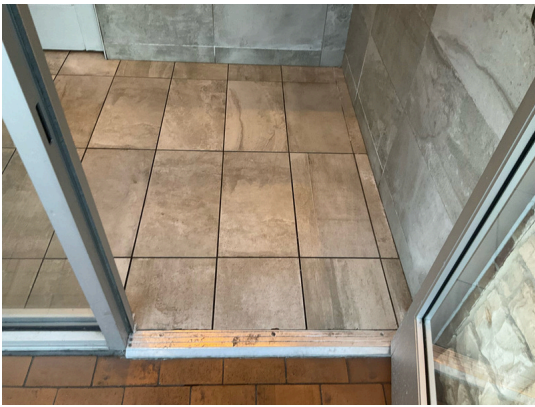
Entrance Mats Photo

Entrance mats present and in good condition?	No
---	----

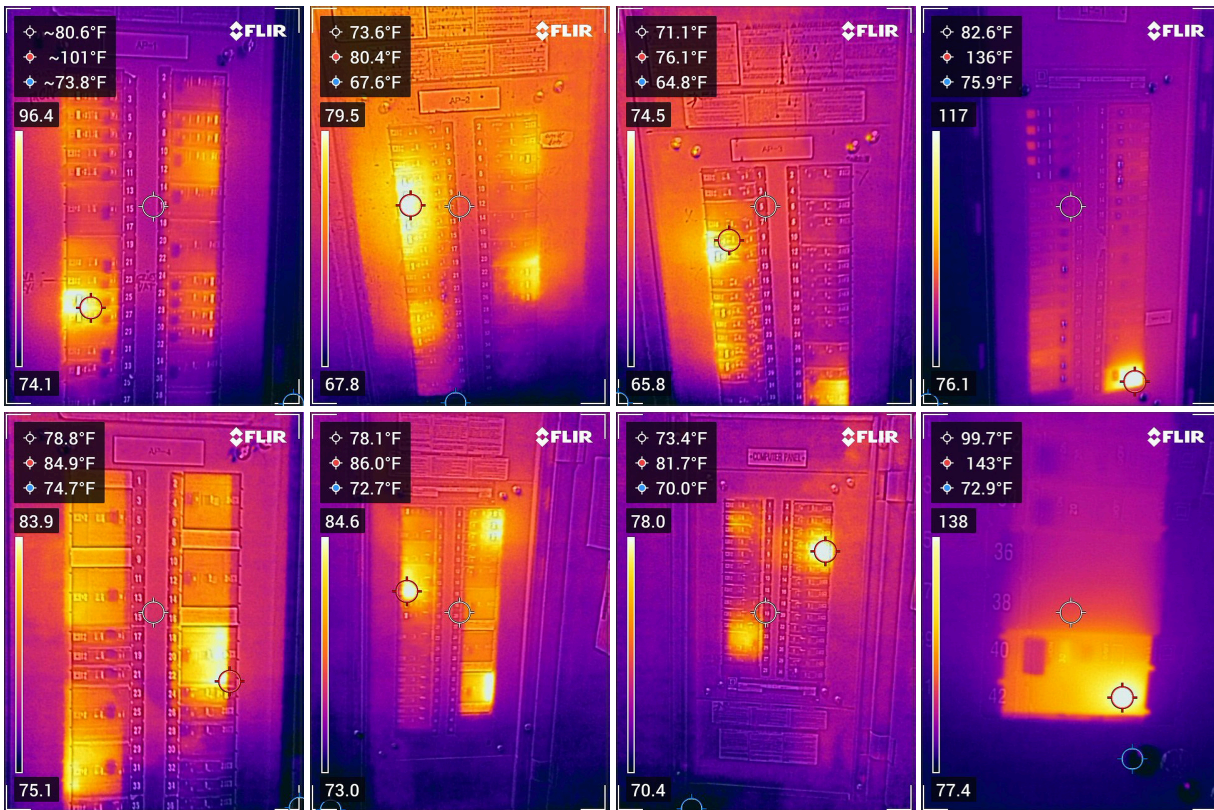
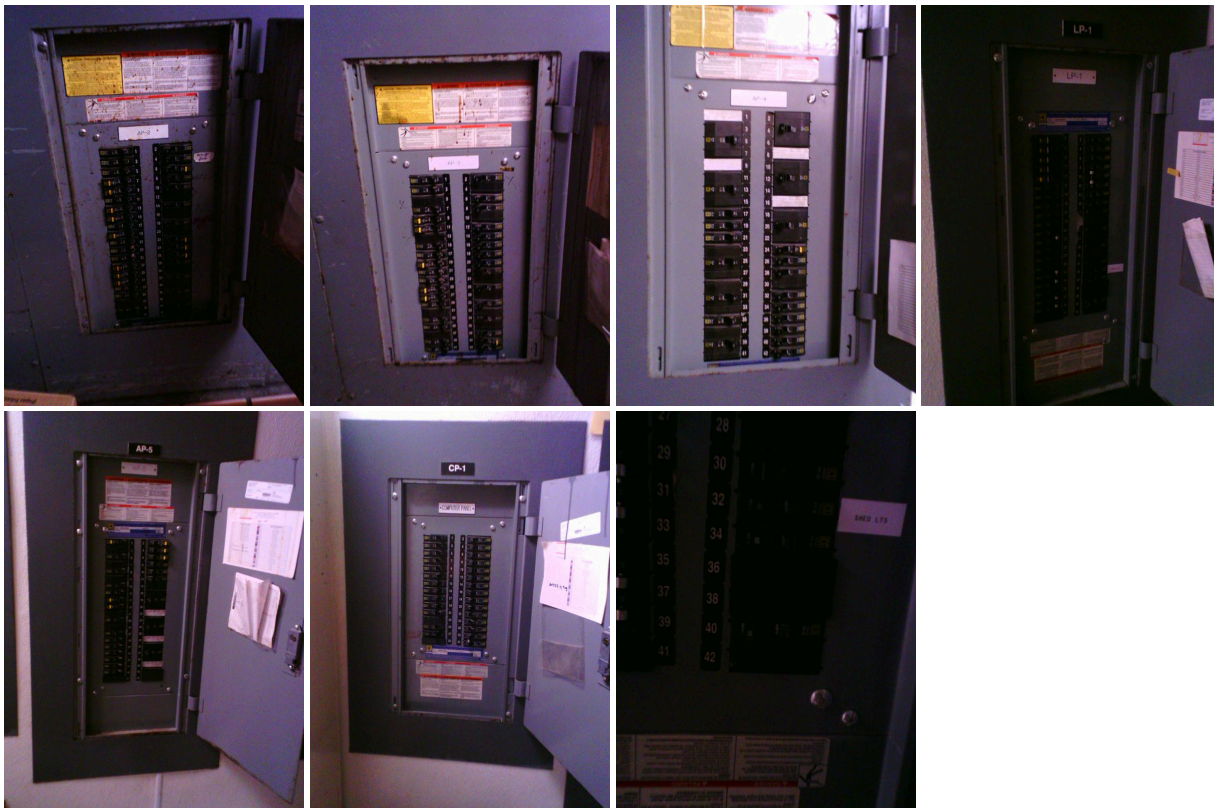
Panel Thermal Photo(s)

36" clearance in front of panel maintained?	Yes
Emissivity confirmed at 0.95?	Yes
Reflected / Atmospheric Temperature (Numeric in °F)	70

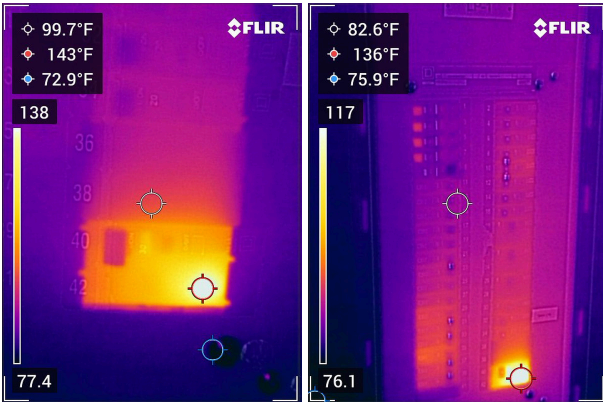
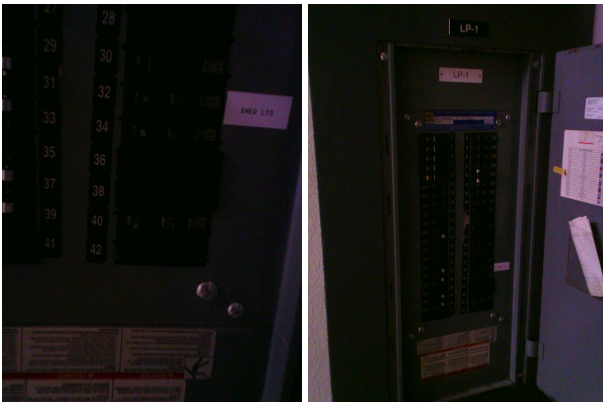
LP1

Highest temperature difference noted on any panel (change of Temp in Fahrenheit vs. ambient or reference phase)

73

Priority 1 - Major Discrepancy (>72°F)
